Re: City of Gallup Wastewater Treatment Plant; Major; Individual Permit; SIC 4952; Compliance Evaluation Inspection; NPDES Permit NM0020672; March 21, 2017

CITY OF GALLUP NPDES PERMIT #NM0020602 COMPLIANCE EVALUATION INSPECTION

DATE OF INSPECTION: MARCH 21, 2017

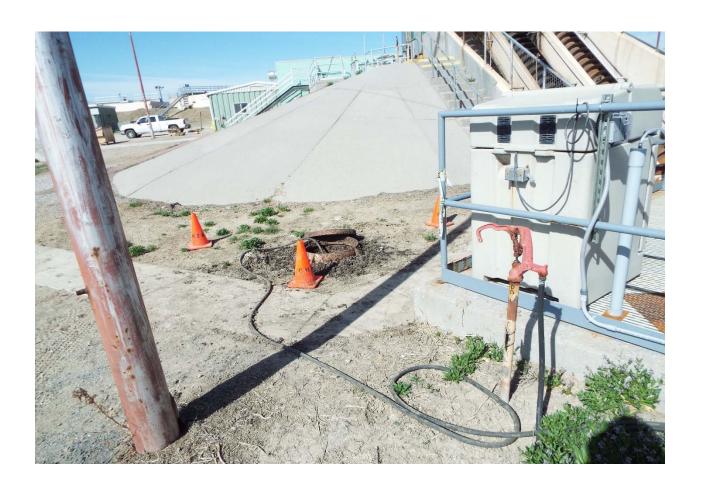
NMED/SWQB Official Photograph Log Photo # 1

Photographer: Daniel Valenta	Date: 03/21/2017	Time: 1048 Hours							
City/County: Gallup/		State: New Mexico							
Location: City of Gallup Wastewater Treatment Plant									
Subject: Manhole overflow within the WWTP.

The permittee has had several Sanitary Sewer Overflows (SSOs). Each SSO has been reported to EPA and NMED. On the date of the inspection, it was noted that there had been a manhole within the WWTP that had an overflow. Discussion with Mr. Quintana and the operator suggested that approximately 70 gallons may have overflowed the manhole but was not reported. Mr. Quintana believed there was a de minimis amount before any overflow needed to be reported. The inspector explained the requirements of the permit. Mr. Quintana stated he would send in all overflow reports with DMRs as needed.

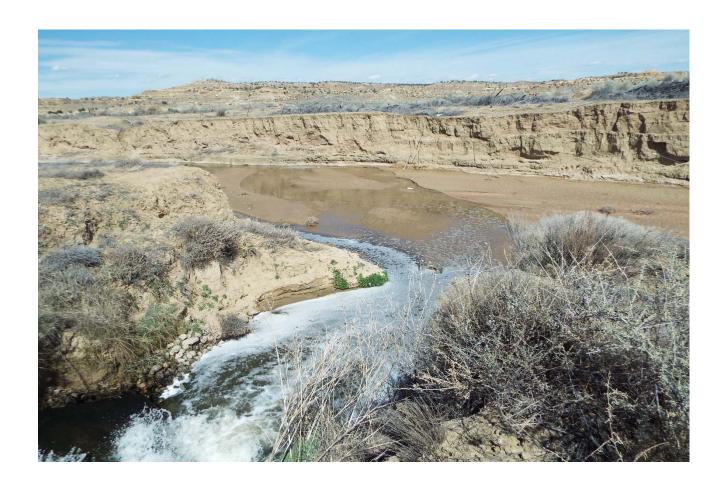
NMED/SWQB Official Photograph Log Photo # 2

Subject: Noticeable foam in the effluent discharge.
